Summary of Demonstration Testing for GE Active PWR Suction Strainer

(GSI-191)

GE Active Strainer Product Demonstration Summary, Conducted January 5-7,

# GE Active Strainer Product Demonstration Summary

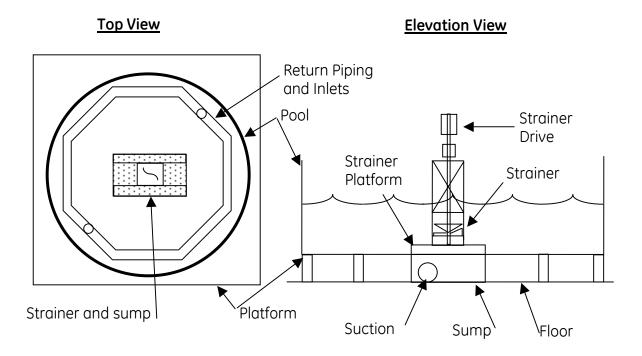
Figure 1: Schematic of Test Facility (Not to Scale)

The test facility, as shown in Figure 1, consists of a test pool mounted on a platform above the floor grade. In the center of the test pool is recessed a rectangular sump that extends from the bottom of the pool to the floor grade.

Covering the sump is a steel platform. The top of the platform is covered in perforated plate, except for the middle 2' by 2' section over which the Active Strainer is mounted. This perforated platform can be blocked to ensure all flow goes through the Active Strainer. During the Day 1 and Day 2 demonstrations the perforated area was open to flow. During the Day 3 demonstration, the perforated area was closed.

The top view below shows the platform, test pool, strainer and sump with part of the return line shown. The elevation view shows more details of the strainer and indicates the location of the suction pipe in the sump. The return flow system is omitted for clarity.

The passive area of the strainer platform (see Figure 1) was blocked with plexi-glass such that all flow was forced to go through the Active Strainer only.

During this demonstration, the strainer platform passive surface area (see Figure 1) was kept open to demonstrate the preferential deposition of debris on passive surfaces. The maximum debris load was increased by a factor of three to conservatively compensate for the preferential deposition of the debris on the passive surface.

The horizontal surface area of the passive strainer platform (see Figure 1) was blocked during this demonstration. Only the vertical passive area (four 6" high  $\times$  2' long areas), immediately below the top perforated plate of the Active Strainer was open. By keeping the strainer platform covered, no credit at all can be taken for passive suction since all of the flow was going through the Active Strainer.

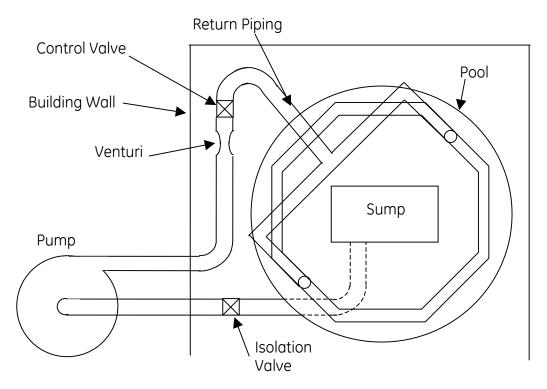
Figure 2: Flow Schematic (Not to Scale)

The flow system is shown in Figure 2 below. A 4500 gpm rated pump circulates the water through the system. The outlet consists of 12" piping, connected to a venturi and then a control valve. After the control valve the piping is teed and reduced to feed an octagonal header near the bottom outside diameter of the pool. Holes drilled in the outside of this header return the flow into the pool. The holes can be plugged to adjust the flow distribution in the pool. The flow then travels from the pool to the strainer and down into the sump. Flow goes to an isolation valve and then returns to the pump.

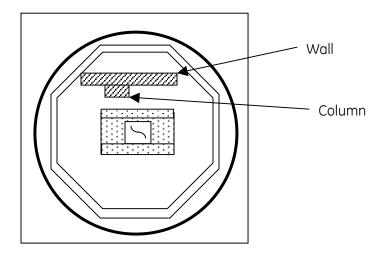
Figure 3: Top View of Pool with Wall and Column (Not to Scale)

Furthermore, during this demonstration a simulated wall and column was placed in proximity of the Active Strainer. The wall and column were introduced to demonstrate Active Strainer functionality in close proximity of different containment structural configurations and constrictions. Visual observations were made regarding debris movement and settling near the wall and column. A top view of the pool, modified with the wall and column is shown below:

Furthermore, as mentioned earlier, the pool configuration was altered to simulate the containment pool at a different plant. By visual inspection, it was shown that there was no debris accumulation between the wall, column and strainer. Instead, debris settled on the other three sides around the strainer.

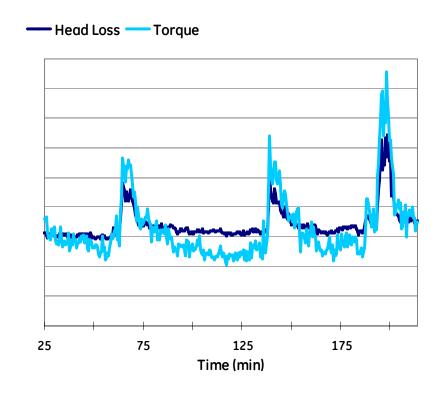
Figure 3 Head Loss and Torque vs. Time for the Day 2 Demonstration

This demonstration began similarly to the Day 1 maximum load demonstration: the calculated maximum debris load of low-density fiber was introduced to the strainer. Although head loss and torque values peaked briefly, both quickly returned to lower steady-state values. Head loss peaked at 7.5" and torque peaked to 9 ft-lbs. Eventually, the debris settled mostly onto the perforated plate of the strainer platform and on the floor of the pool.

After approximately 60 *min*, a second incremental low-density fibrous load was introduced to the pool. The previous debris load was still present in the pool. Again, head loss and torque briefly peaked to similar values as after the initial load was introduced.

This process was repeated two more times, showing similar results. The head loss and torque peak generally lasted a short time as each debris load was added to the pool.

The head loss and torque values are summarized in the following figure.

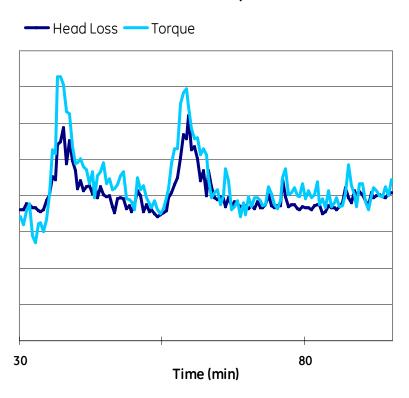
Figure 5 Head Loss and Torque vs. Time for the Day 3 Demonstration

Like the previous two demonstrations, the head loss and torque showed peak values and then returned to steady-state values. However, because of the increased load, peak values lasted somewhat longer than previous cases. The peak values of head loss and torque are on the order of previously demonstrated peaks.

After the peaks occurred, the Active Strainer reached a steady state and head loss and torque returned to levels as previously demonstrated.

The head loss and torque values are summarized in the following figure.
